APPENDIX D: CHANNEL AND RIPARIAN AERIAL ASSESSMENT

DEARBORN TMDL PLANNING AREA

Channel and Riparian Aerial Assessment

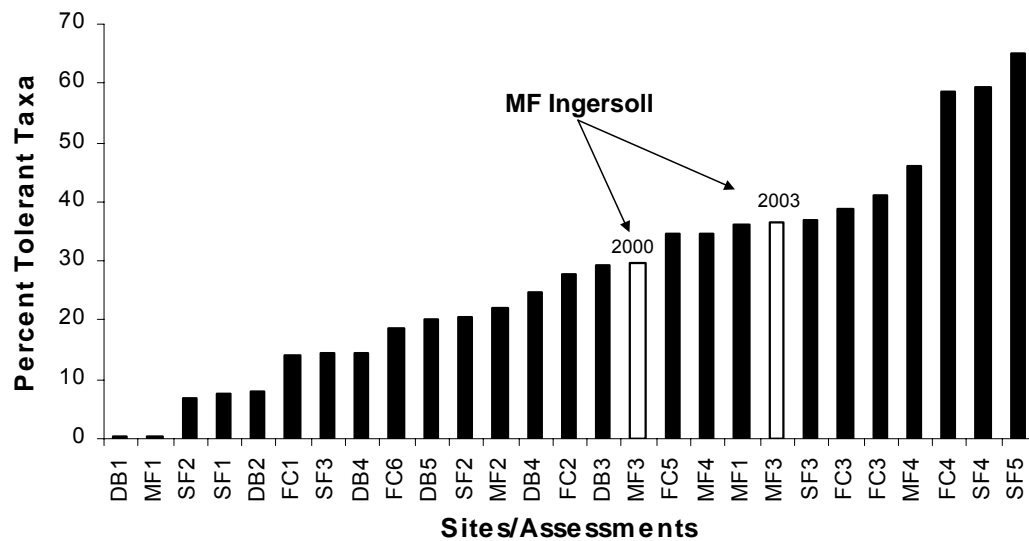
Figure C-1. Range of values for the metric Percent Tolerant Taxa over a 4-year sampling period, arranged in ascending order, by site. Several sites were sampled in both 2002 and 2003; a few sites had samples collected only in 2000.

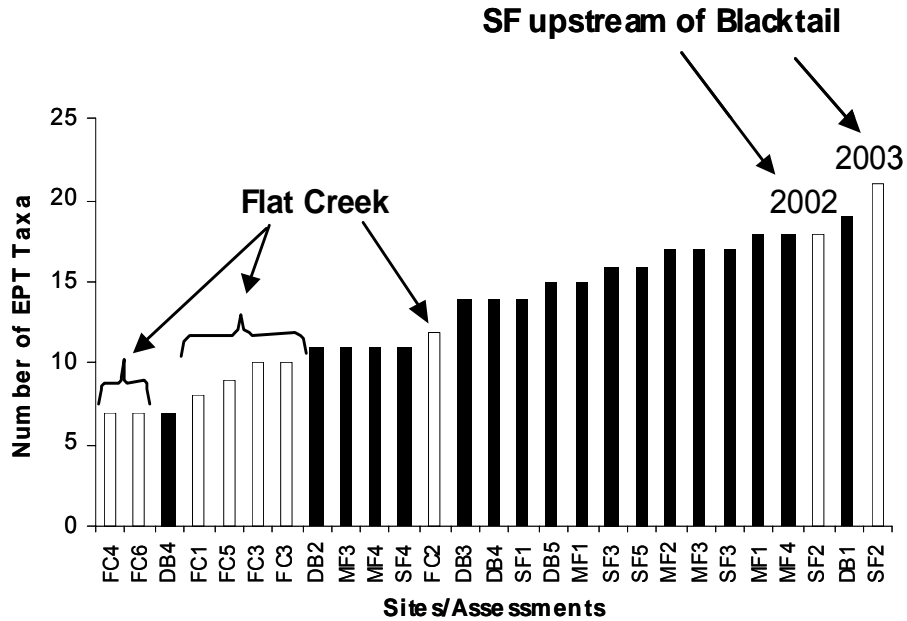
Figure C-2. Range of values for the metric Number of EPT Taxa over a 4-year sampling period, arranged in ascending order by site. Several sites were sampled in both 2002 and 2003.

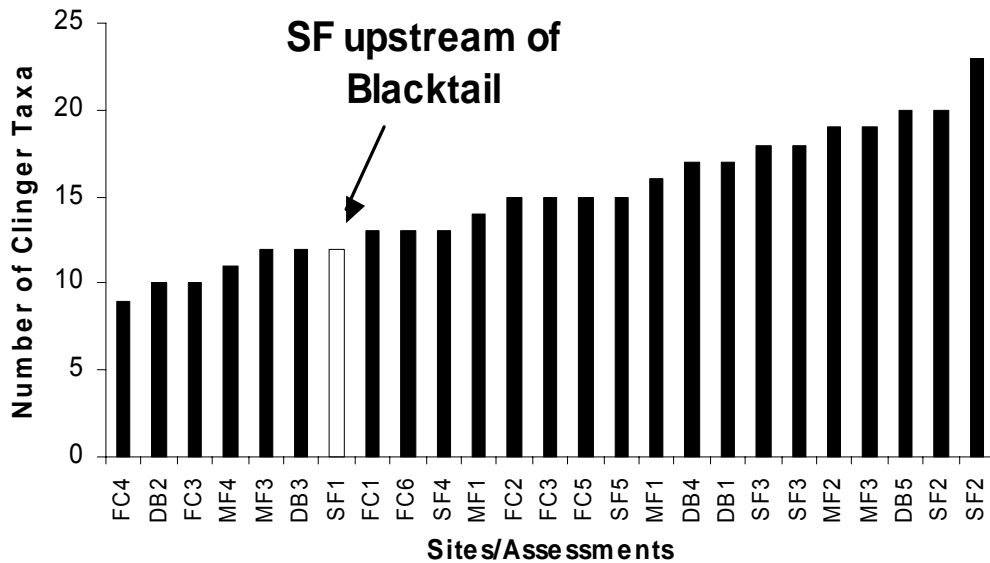
Figure C-3. Range of values for the metric Number of Clinger Taxa over a 4-year sampling period, arranged in ascending order by site. Several sites were sampled in both 2002 and 2003; a few sites had samples collected only in 2000.

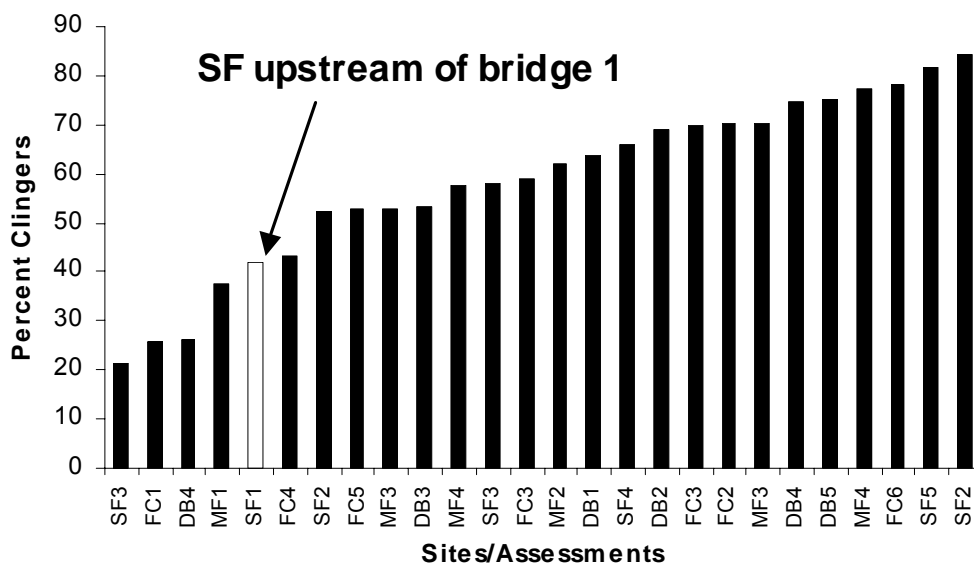
Figure C-4. Range of values for the metric Percent Clingers over a 4-year sampling period, arranged in ascending order, by site. Several sites were sampled in both 2002 and 2003; a few sites had samples collected only in 2000.

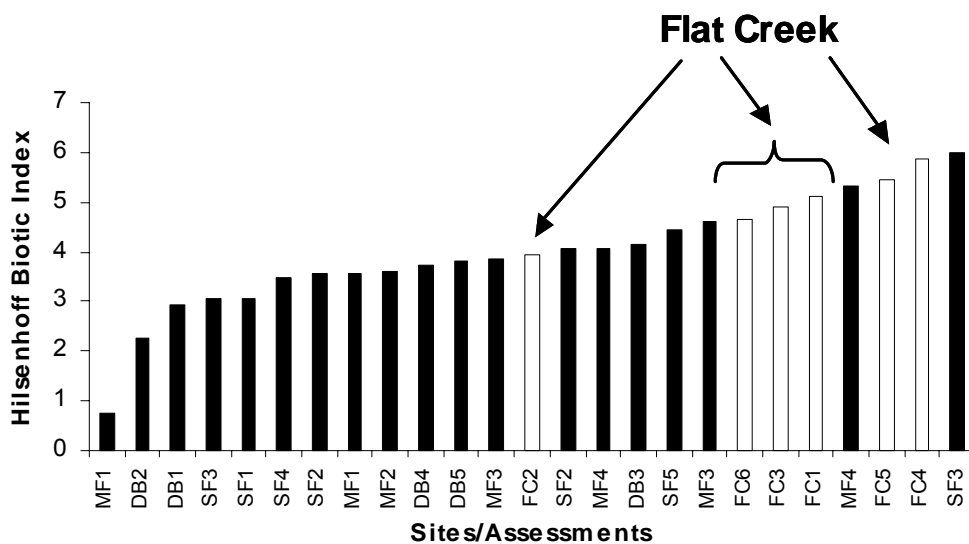
Figure C-5. Range of values for the metric Hilsenhoff Biotic Index over a 4-year sampling period, arranged in ascending order, by site. Several sites were sampled in both 2002 and 2003; a few sites had samples collected only in 2000.

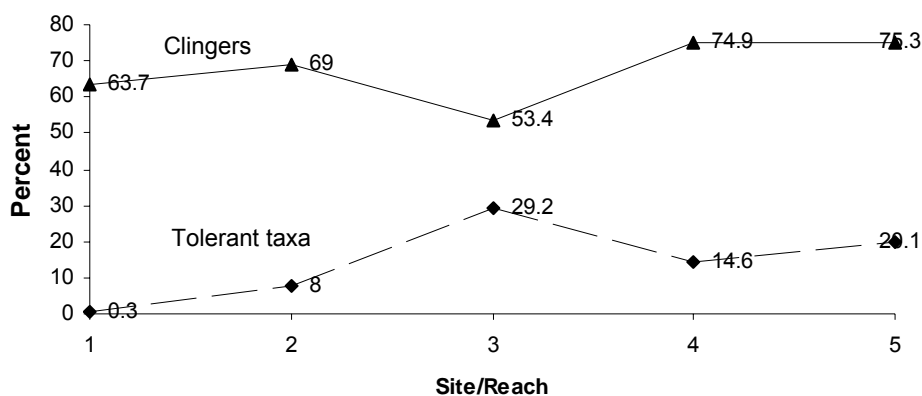
Figure C-6. Percent Clingers and Percent Tolerant Taxa from five reaches sampled on the Dearborn River mainstem from 2000-2003; the most recent data from each site are used. Reach numbers refer to Table C-1.

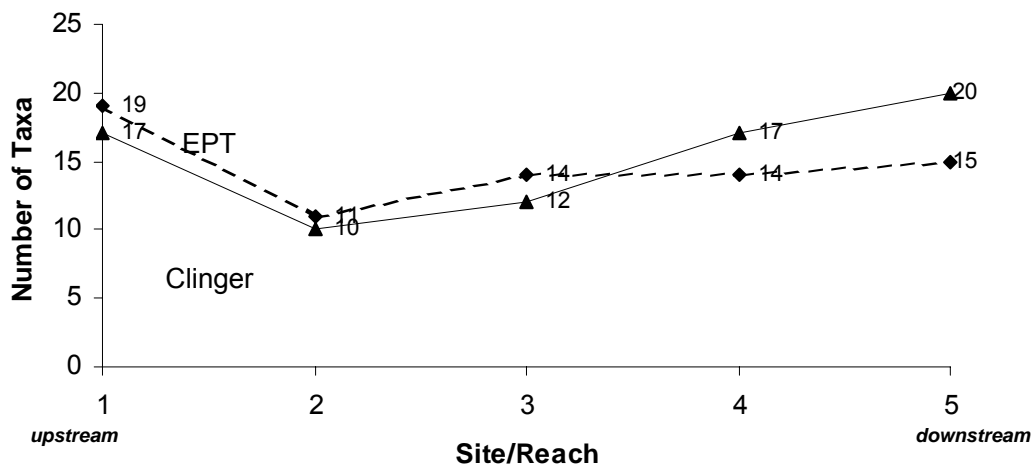
Figure C-7. Number of EPT Taxa and Clinger Taxa sampled from five reaches on the Dearborn River mainstem from 2000-2003; the most recent data from each site are used. Reach numbers refer to Table C-1.

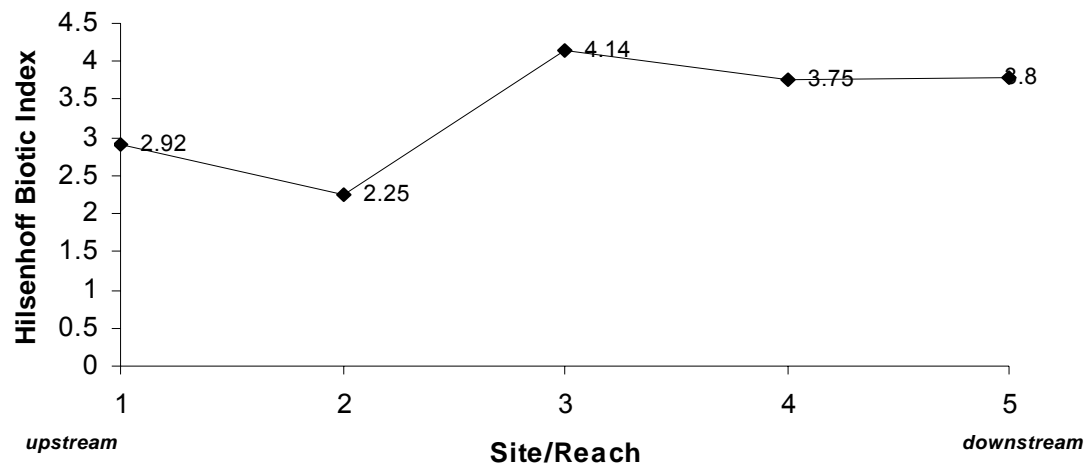
Figure C-8. Hilsenhoff Biotic Index from samples taken along five reaches of the Dearborn River mainstem from 2000-2003; the most recent data from each site are used. Reach numbers refer to Table C-1.

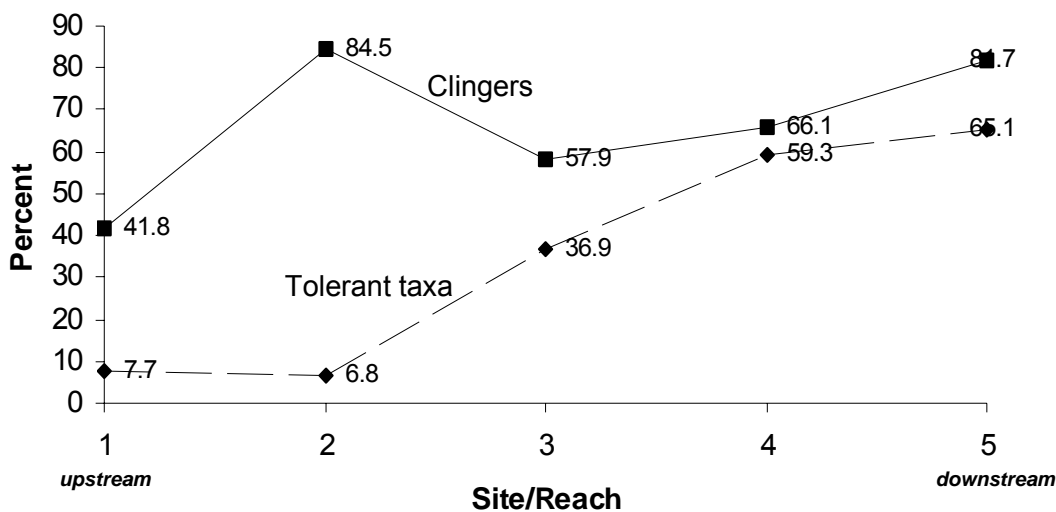
Figure C-9. Percent clingers and percent tolerant along 5 sites of the South Fork Dearborn River, sampled from 2000-2003; the most recent data from each site are used. Reach numbers refer to Table C-2.

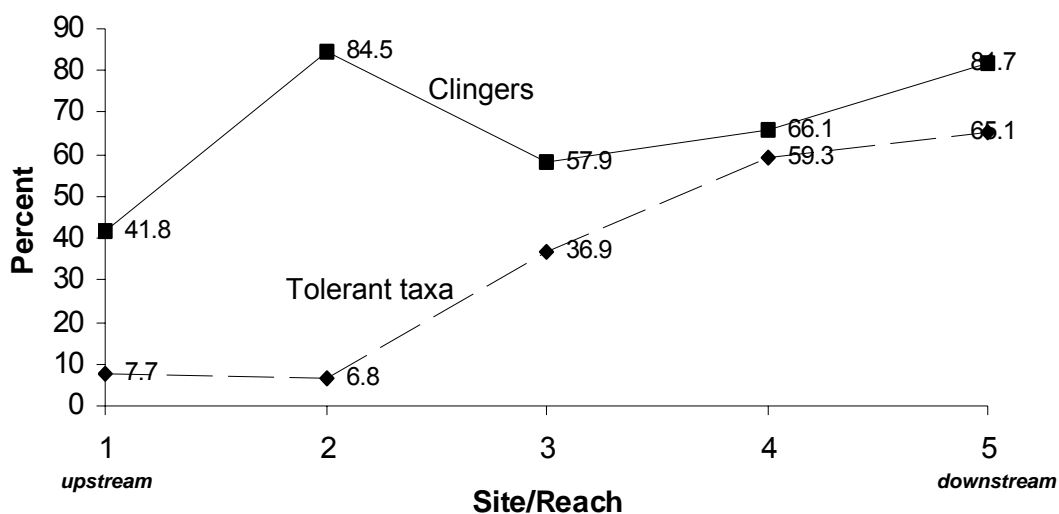
Figure C-10. Percent clingers and percent tolerant along 5 sites of the South Fork Dearborn River, sampled from 2000-2003; the most recent data from each site are used. Reach numbers refer to Table C-2.

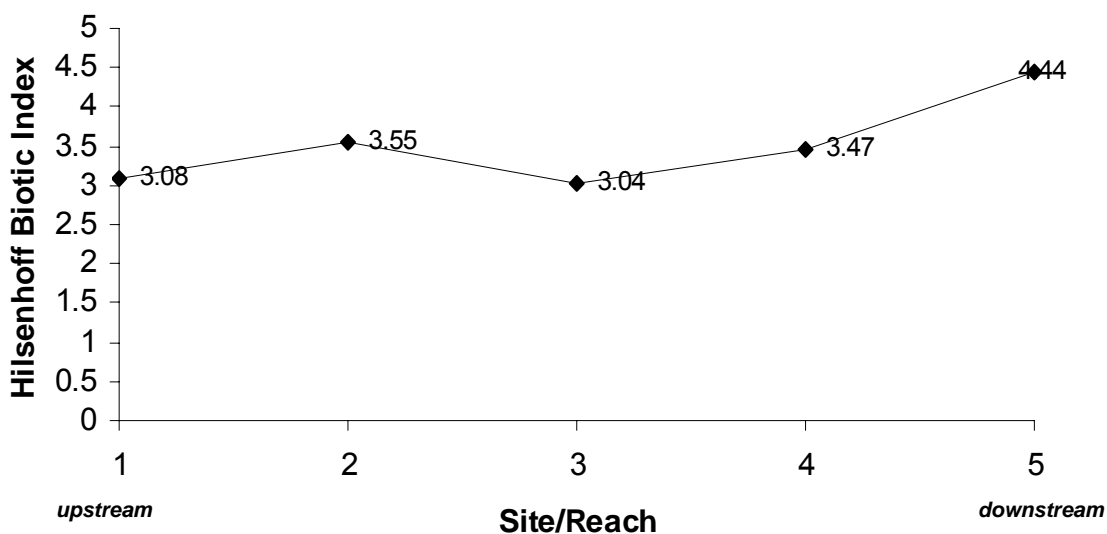
Figure C-11. Hilsenhoff Biotic Index from samples collected along 5 sites of the South Fork Dearborn River, sampled from 2000-2003; the most recent data from each sites are shown. Reach numbers refer to Table C-2.

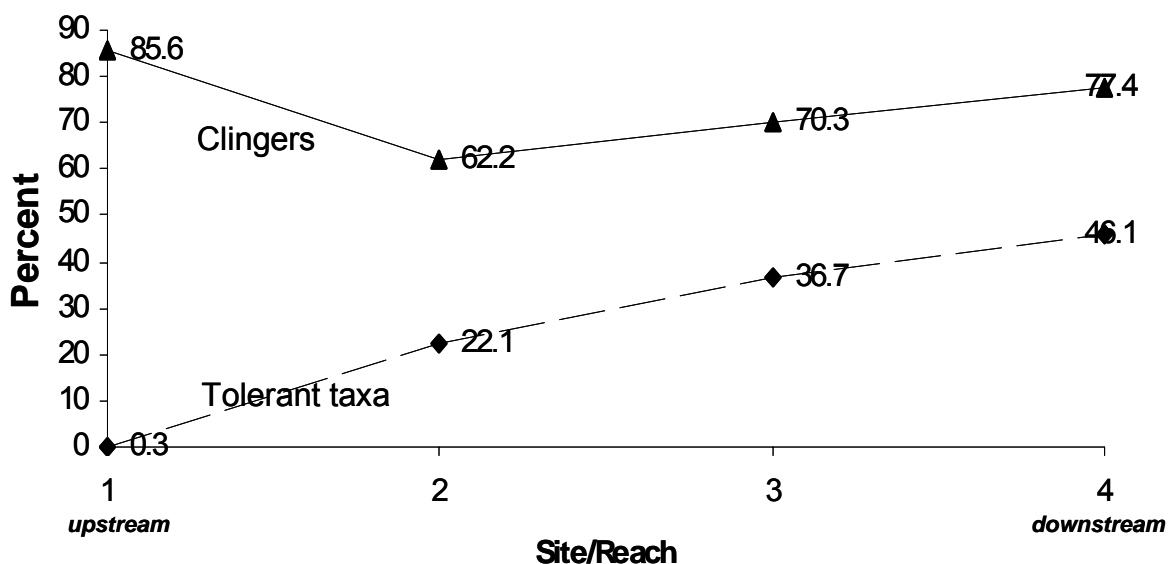
Figure C-12. Percent clingers and tolerant taxa from samples collected along 4 sites of the Middle Fork Dearborn River, sampled from 2000-2003; the most recent data from each site are shown. Reach numbers refer to Table C-3.

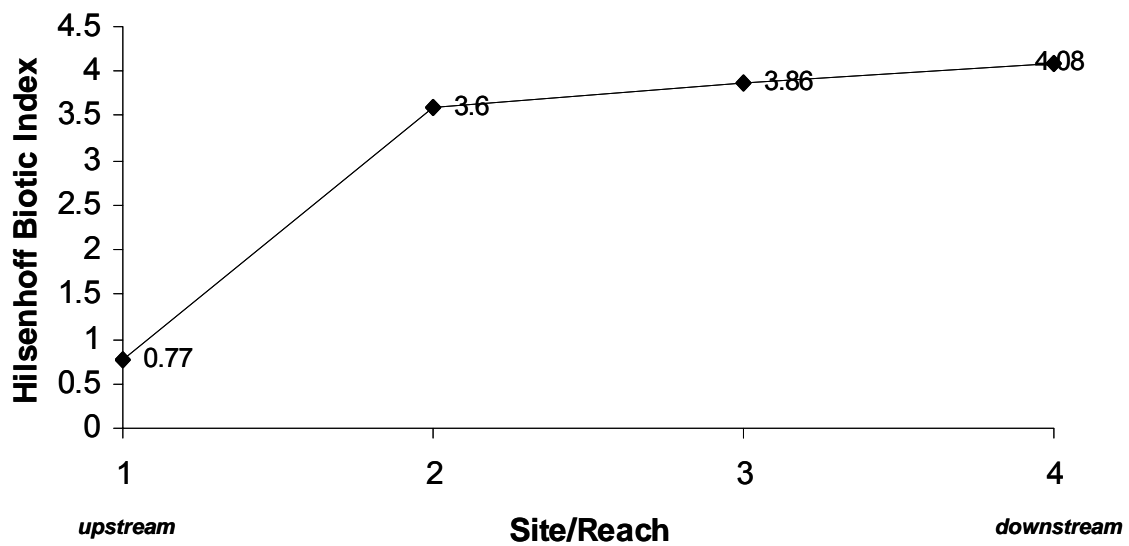
Figure C-13. Hilsenhoff Biotic Index from samples collected along 4 sites of the Middle Fork Dearborn River, sampled from 2000-2003; the most recent data from each site are shown. Reach numbers refer to Table C-3.

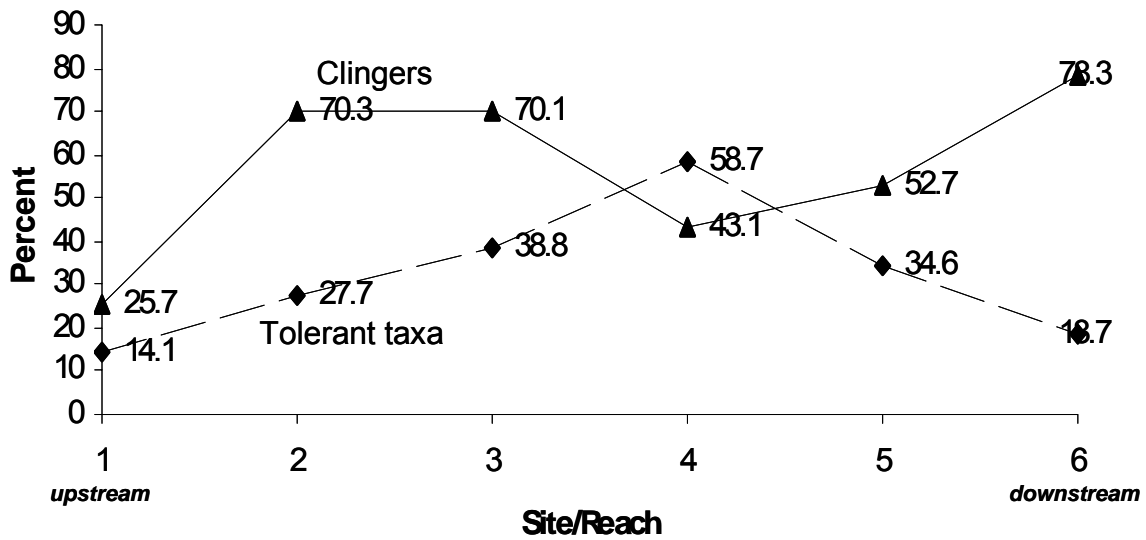
Figure C-14. Percent clingers and tolerant taxa from samples collected along 6 sites of the Flat Creek mainstem, sampled from 2000-2003; the most recent data from each site are shown. Reach numbers refer to Table C-4.

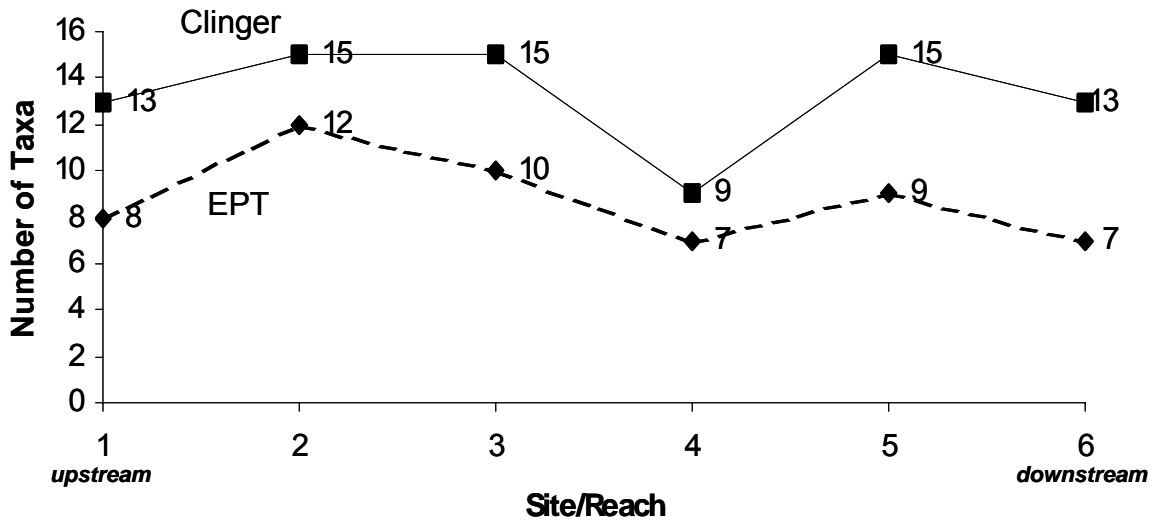
Figure C-15. Number of clinger and EPT taxa from samples collected along 6 sites of the Flat Creek mainstem, sampled from 2000-2003; the most recent data from each site are shown. Reach numbers refer to Table C-4.

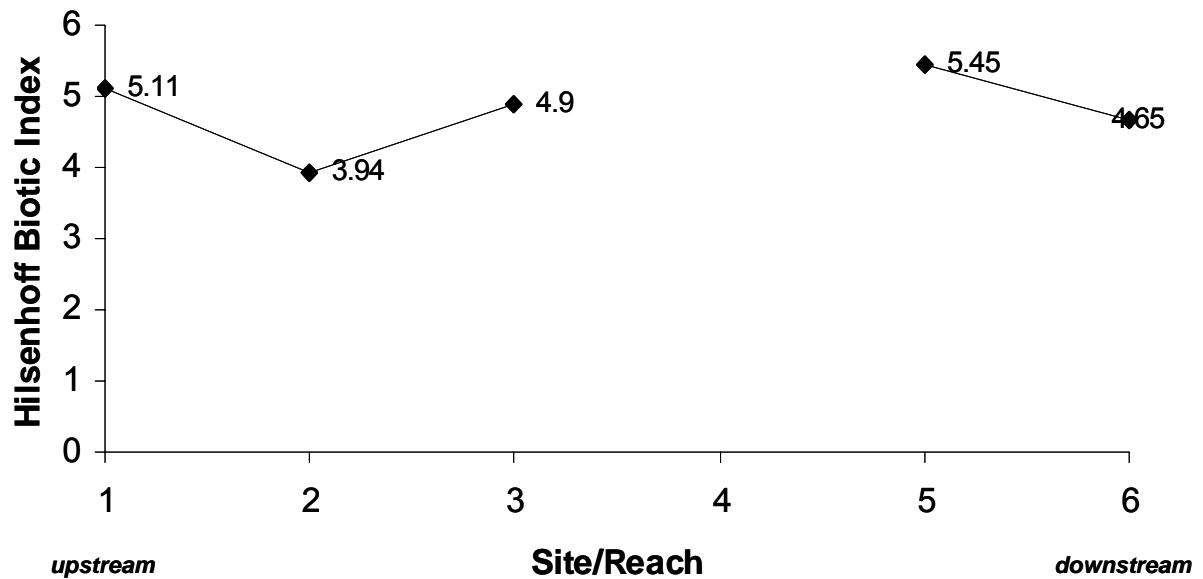
Figure C-16. Hilsenhoff Biotic Index from samples collected along 6 sites of the Flat Creek mainstem, sampled from 2000-2003; the most recent data from each site are shown. Reach numbers refer to Table C-4.

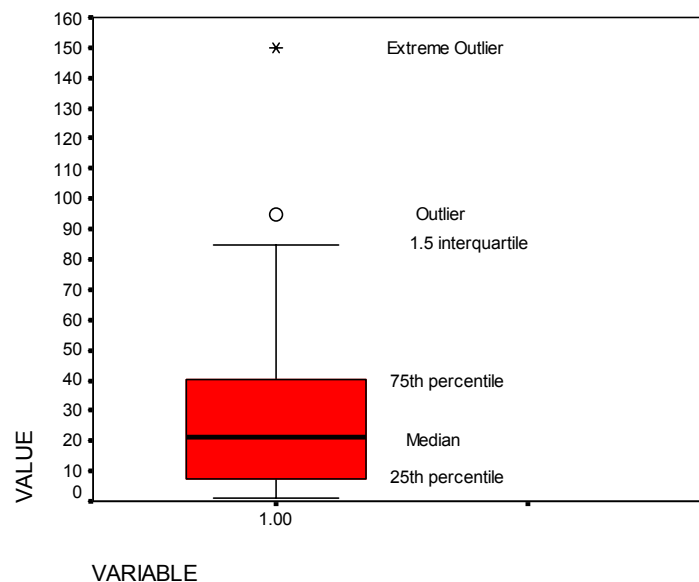
Figure 3-1. Example Boxplot

The central black bar is the median or 50th percentile value, which is equivalent to the average when data are normally distributed. The 25th and 75th percentiles are shown as the lower and upper extents of the box. The “whiskers” represent the value of 1.5 times the interquartile range. Circles represent outliers in the distribution of data, and asterisks represent extreme outliers. Normally distributed data would have a symmetrical form around the median value.

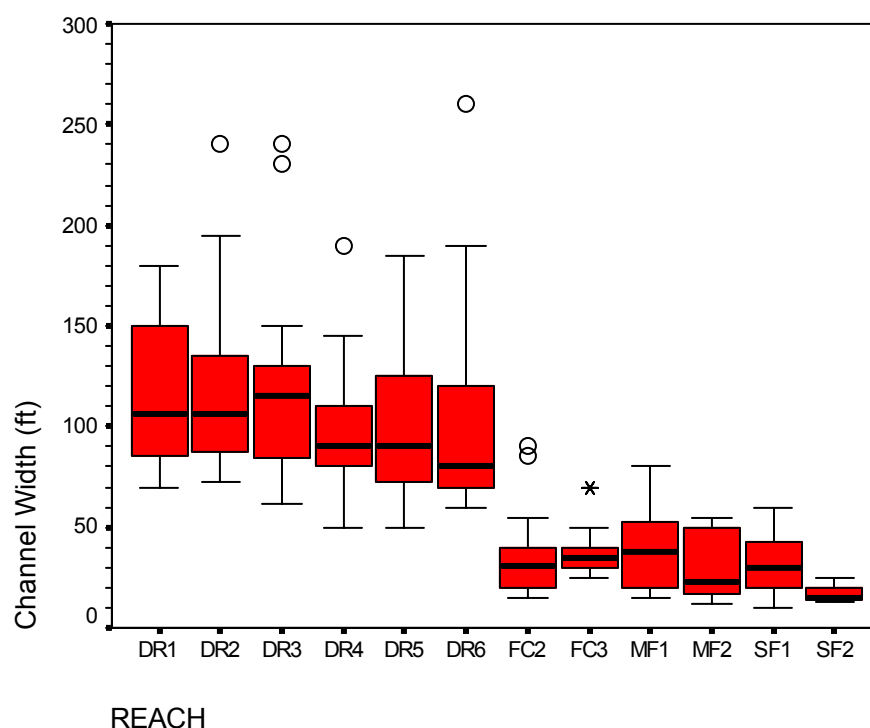
Figure 3-2 Channel Width in the Dearborn Watershed in 1995

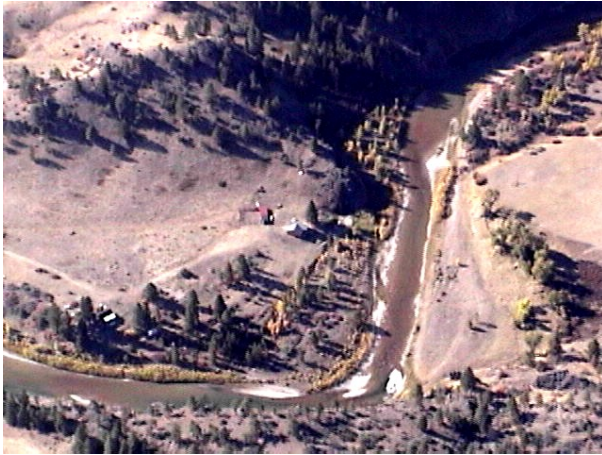
Figure 3-3. Dearborn Reach DR1

Shade provided by riparian vegetation to the stream channel was very limited on all reaches of the Dearborn mainstem. This resulted in part from low to moderate tree densities and canopy coverage, but also because tree heights and offset from the channel resulted in minimal shade projected to the water surface (e.g. **Figure 3-3**). Channel widths exceeding 100 feet limited effective shading potential from even mature Cottonwood stands adjacent to the river. The majority of shade to the Dearborn mainstem was related to topographic influences (see **Figures 3-3, 3-4, 3-7**).

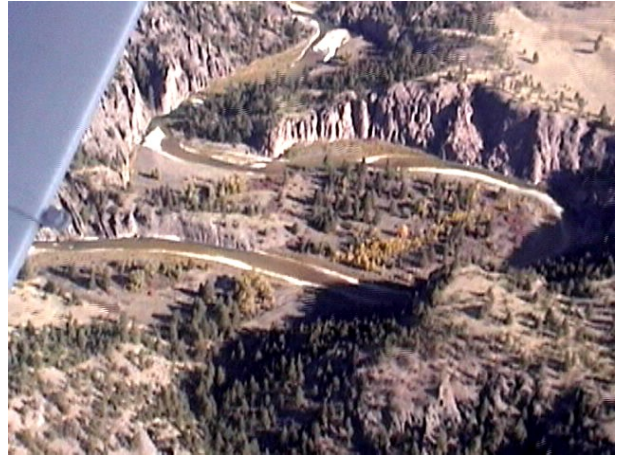
Figure 3-4. Dearborn Reach DR2

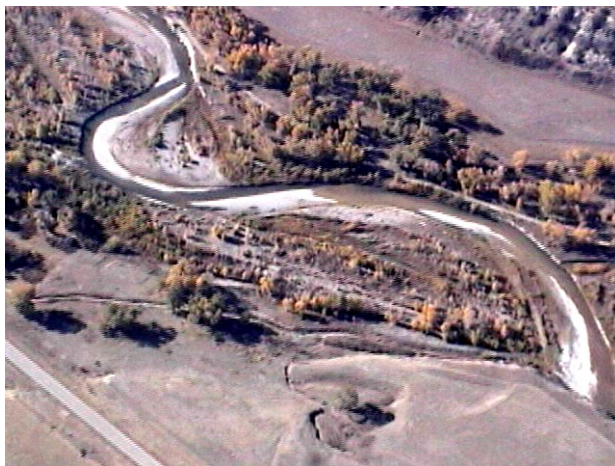
Figure 3-5. Dearborn Reach DR3

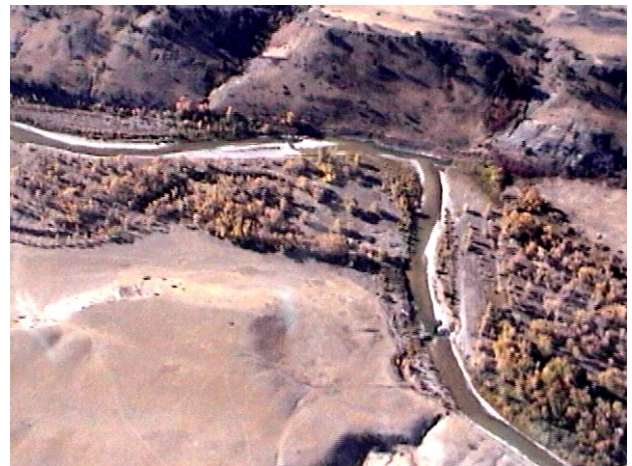
Figure 3-6. Dearborn Reach DR4

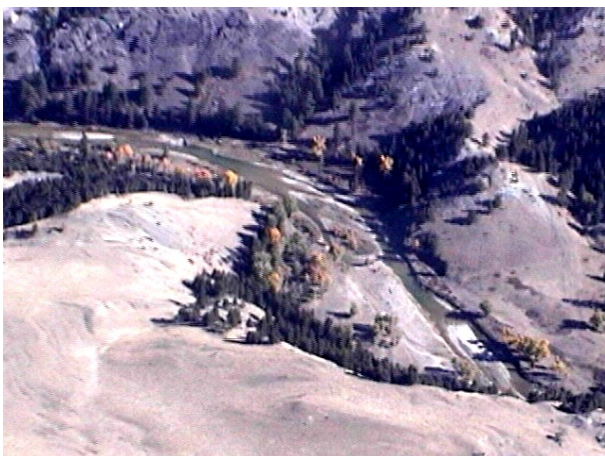
Figure 3-7. Dearborn Reach DR5

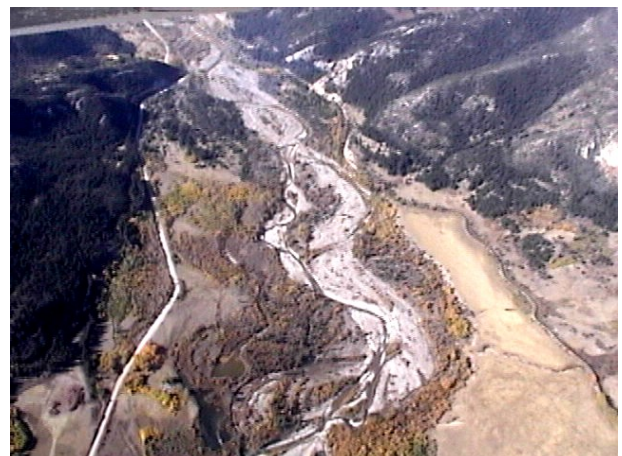
Figure 3-8. Dearborn Reach DR6

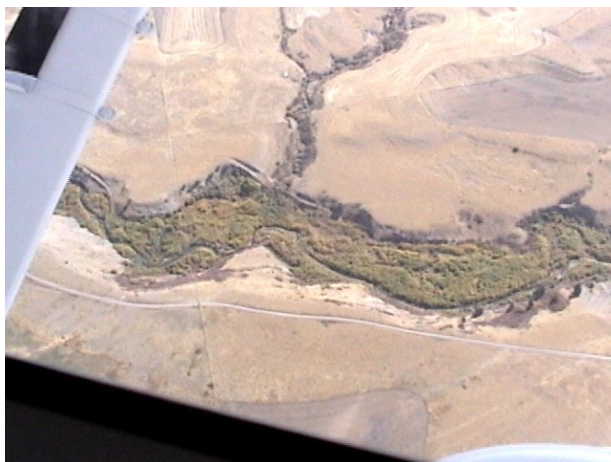
Figures 3-9 and 3-10 contrast the ‘good’ and ‘poor’ riparian conditions for the South Fork of the Dearborn in the lower reach SF1. Woody species were predominately shrub/willow in ‘good’ reaches. Loss of riparian corridor due to conversion to agricultural uses resulted in reduced riparian buffer widths in many locations.

Figure 3-9. Central Portion of South Fork SF1 ‘Good’

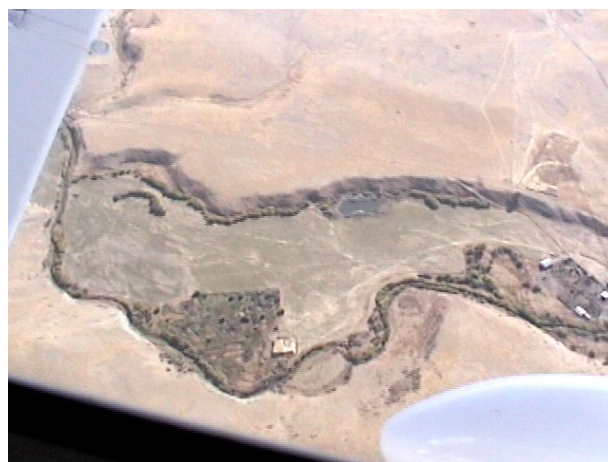
Figure 3-10. Central Portion of South Fork SF1 ‘Poor’

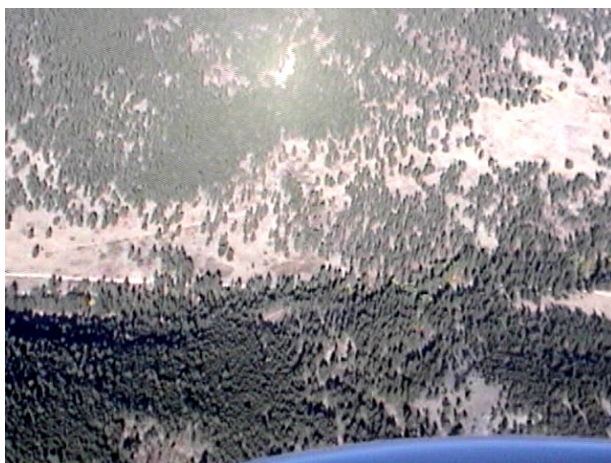
The headwaters portion of the South Fork SF2 was primarily coniferous forest and did not show any significant influence from anthropogenic activities (**Figure 3-11**). Portions of the central and lower section of South Fork reach SF2 appeared to reflect the impacts of logging and riparian vegetation clearing (**Figure 3-12**). The aerial assessment could not determine whether grazing also impacted riparian coverage in this reach.

Figure 3-11. Upper Portion of South Fork SF2 ‘Good’

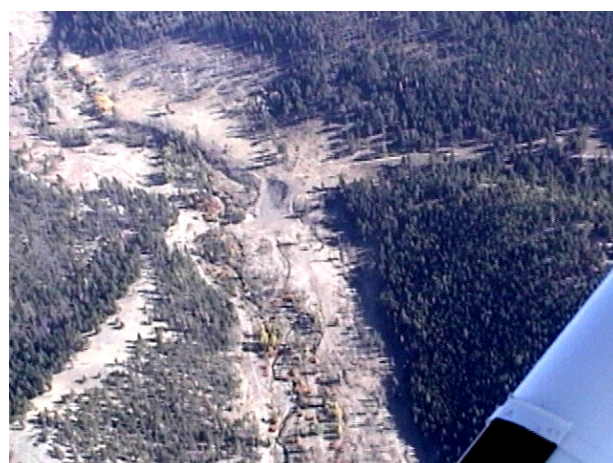
Figure 3-12. Lower Portion of South Fork SF2 ‘Poor’

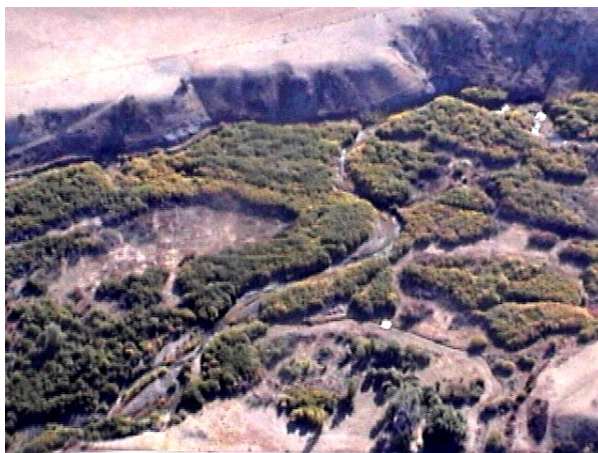
Figures 3-13 to 3-15 contrast ‘good’ and ‘poor’ riparian conditions for the Middle Fork in the lower reach MF1. Woody species in the lower reach of the Middle Fork (MF1) were primarily woody shrubs. Tree components were not a significant part of the overall riparian coverage in ‘good’ reaches (**Figure 3-13**). Extensive clearing of riparian vegetation was apparent in the lower reach of the Middle Fork (**Figures 3-14 and 3-15**). The upper reach MF2 in the headwaters of the Middle Fork was mainly coniferous forest and was not significantly impacted by land use (**Figure 3-16**). Encroachment on riparian vegetation by Highway 200 was minimal except in a short section at the lower end of reach MF2.

**Figure 3-13. Middle Fork Dearborn (MF1)
‘Good’ Reach**

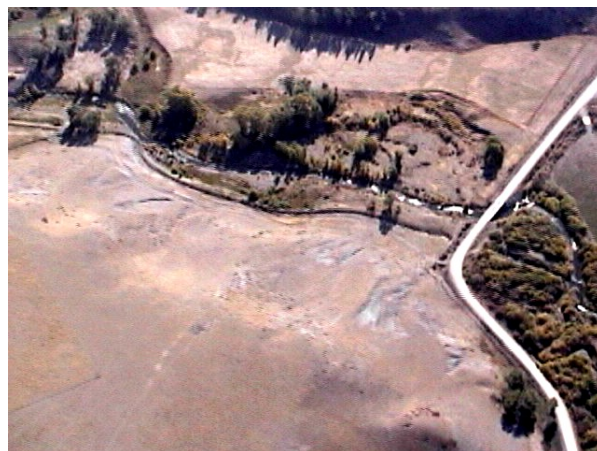
**Figure 3-14. Middle Fork Dearborn (MF1)
‘Fair’ Reach**

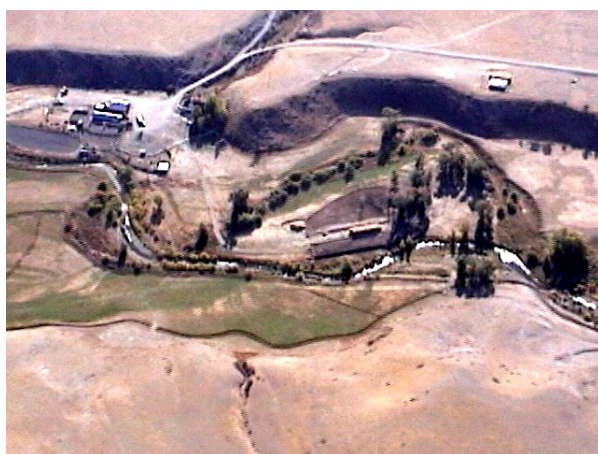
**Figure 3-15. Middle Fork Dearborn (MF1)
‘Poor’ Reach**

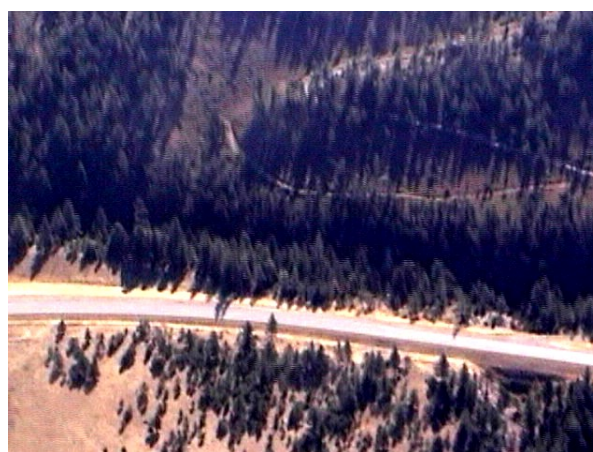
**Figure 3-16. Middle Fork Dearborn (MF2)
Reach**

Overall, riparian vegetation in MF1 was lacking in deciduous tree and woody shrub components and was not in optimal condition relative to site potential. The headwaters reach MF2 appeared to be in good condition with a full complement of conifer/deciduous overstory in most areas except for a short section in the lowermost portions near Highway 200.

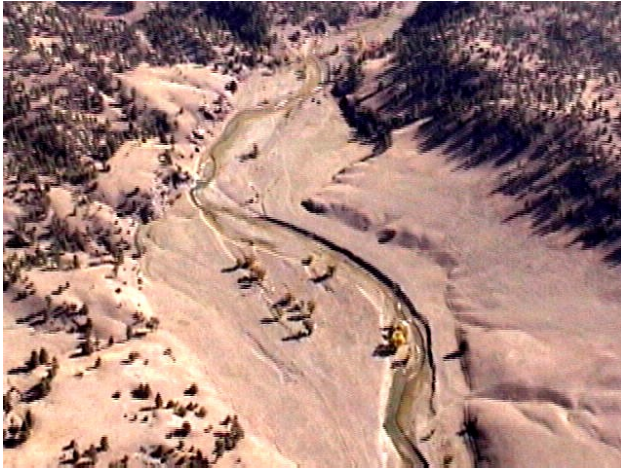
**Figure 3-17. Flat Creek Reach FC1
Unconfined Lower Reach**

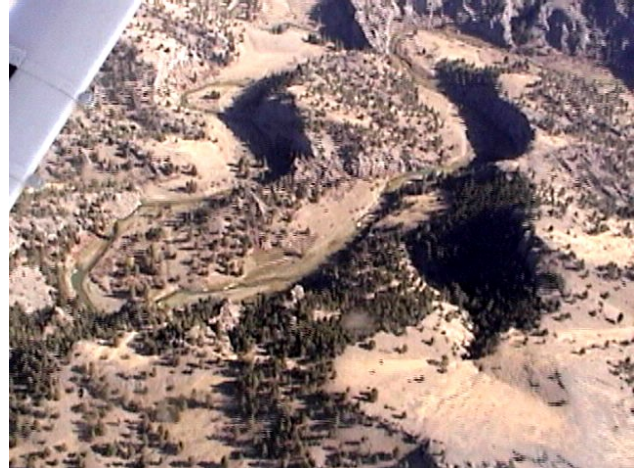
**Figure 3-18. Flat Creek Reach FC1
Confined Lower Reach**

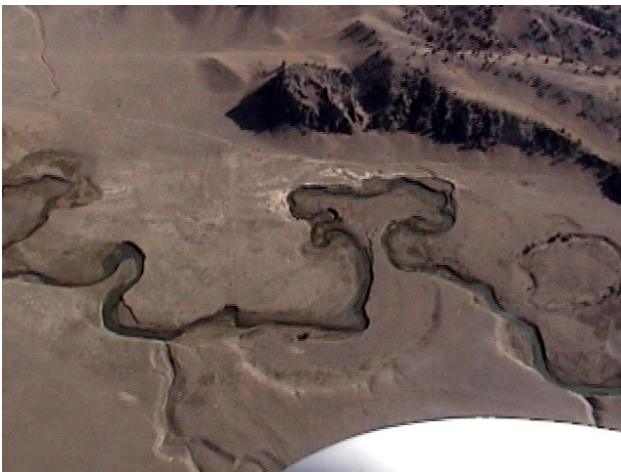
Figure 3-19. Flat Creek Reach FC2 Reach

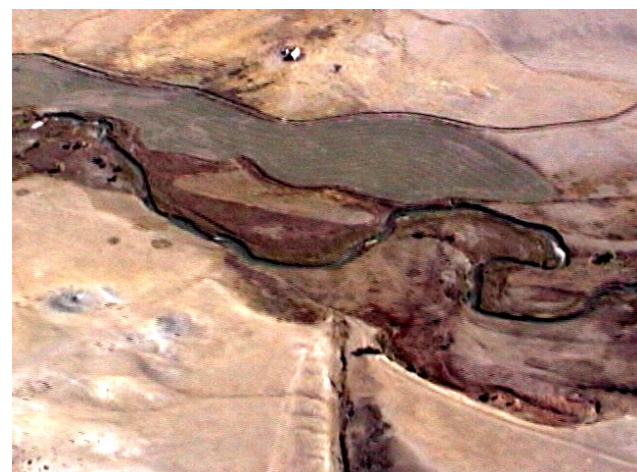
Figure 3-20. Flat Creek Reach FC3 Reach

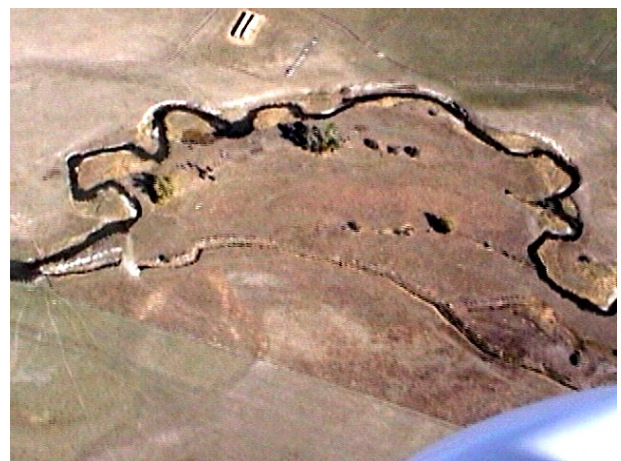
Figure 3-21. Flat Creek Reach FC4 Reach

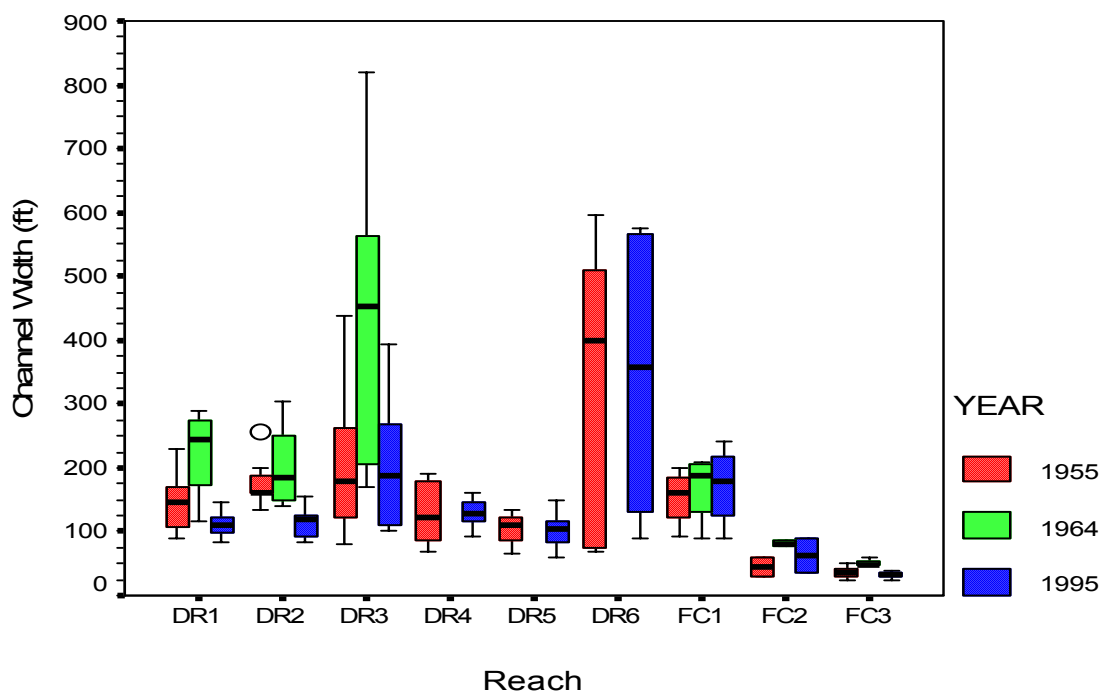
Figure 3-22. Estimated Channel Width in the Dearborn Planning Area in 1955, 1964, and 1995

In general, measurements showed that channel widths increased substantially following the 1964 flood, and that 1995 widths were comparable to pre-flood (1955) values (**Figure 3-22**).

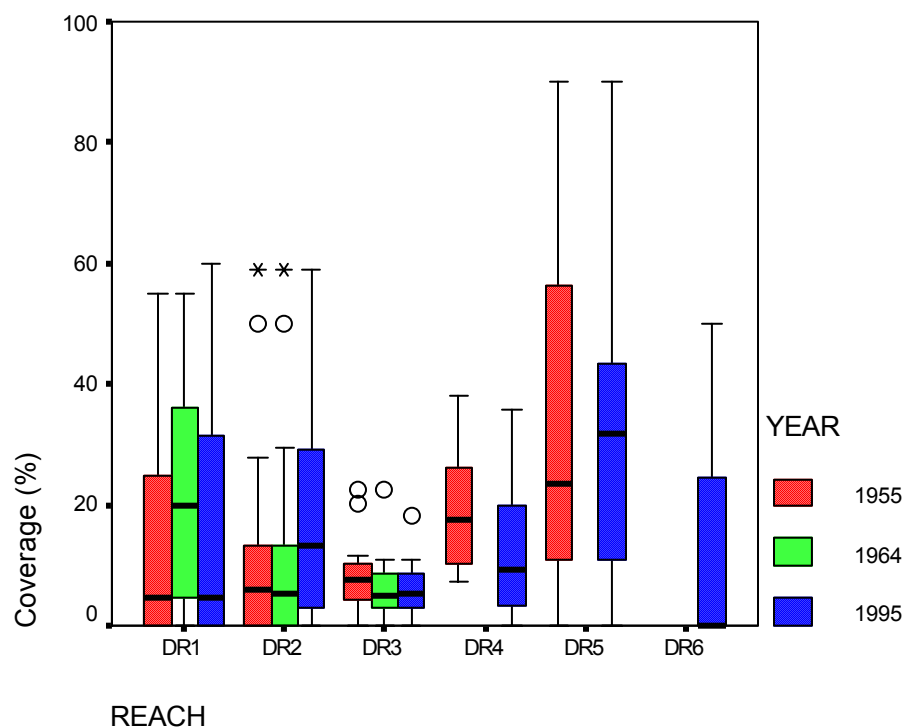
Figure 3-23. Conifer/Deciduous Coverage in the Dearborn Mainstem in 1955, 1964, and 1995

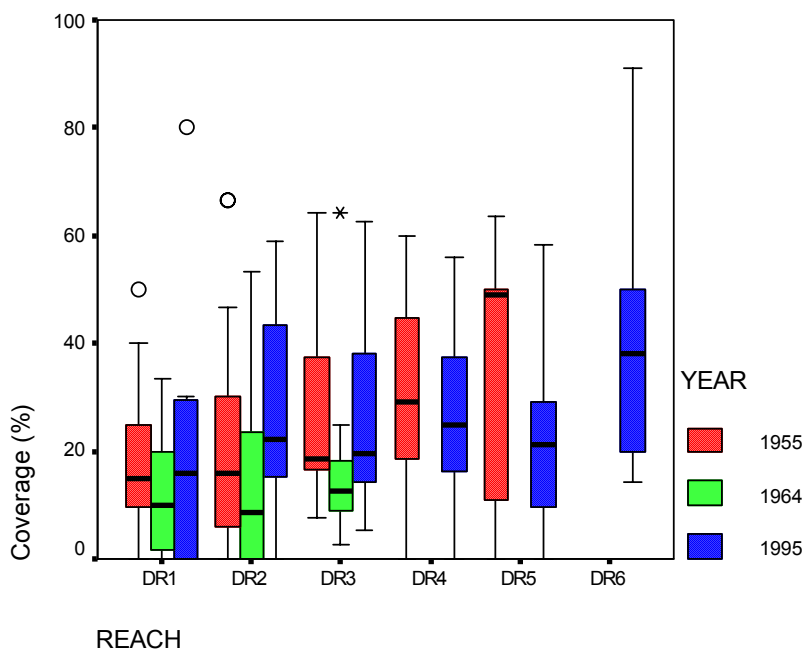
**Figure 3-24. Woody Shrub Coverage in the Dearborn Mainstem in 1955, 1964, and 1995**

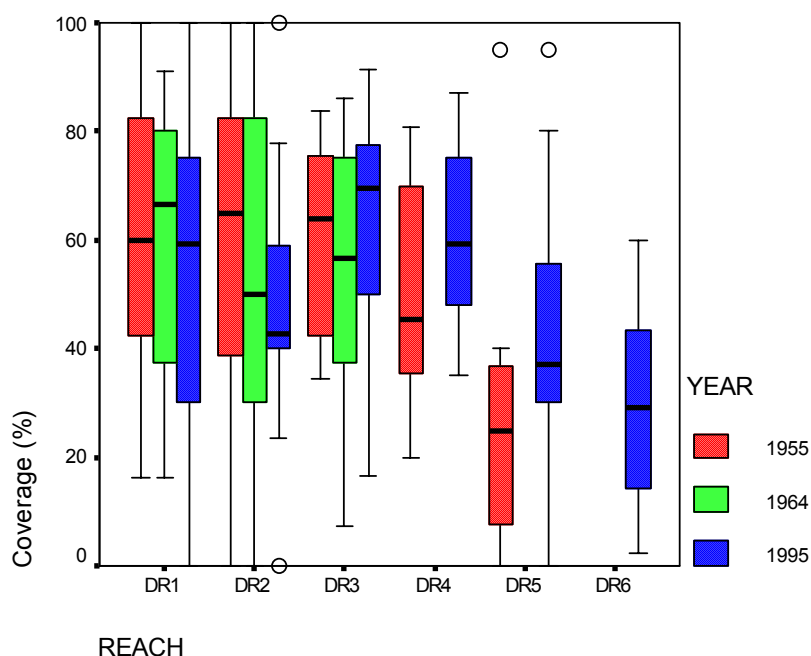
Overall, herbaceous coverage tended to increase in the downstream direction with median values of 60-70% in the lower reaches, and values of 20-40% in the upper reaches (**Figure 3-25**).

Figure 3-25. Herbaceous Coverage in the Dearborn Mainstem in 1955, 1964, and 1995

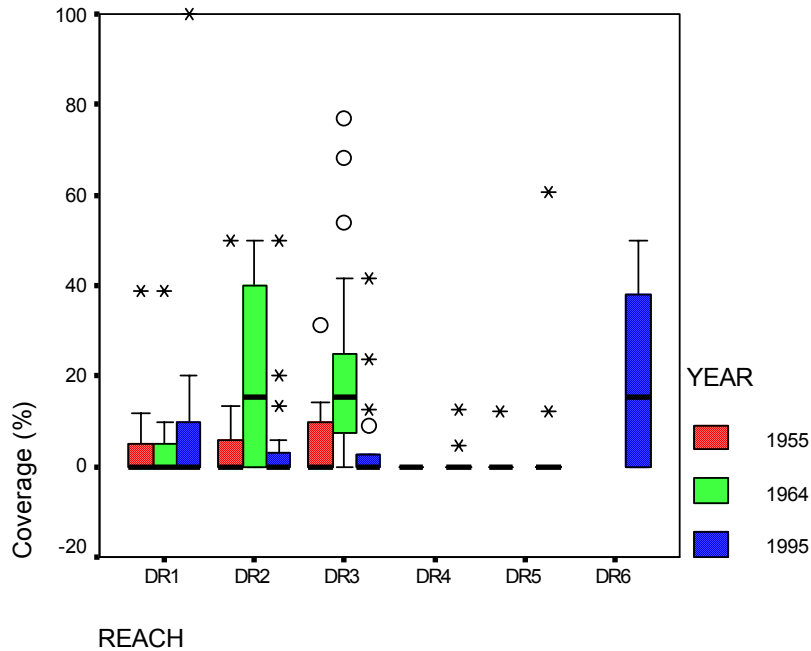
Overall, bare ground was a minor component in riparian areas, generally less than 10% (**Figure 3-26**). Significant increases in disturbed, bare ground was observed following the 1964 flood in DR2 and DR3. This increase in disturbed ground returned to pre-flood levels in 1995.

Figure 3-26. Bare Ground in the Dearborn Mainstem in 1955, 1964, and 1995

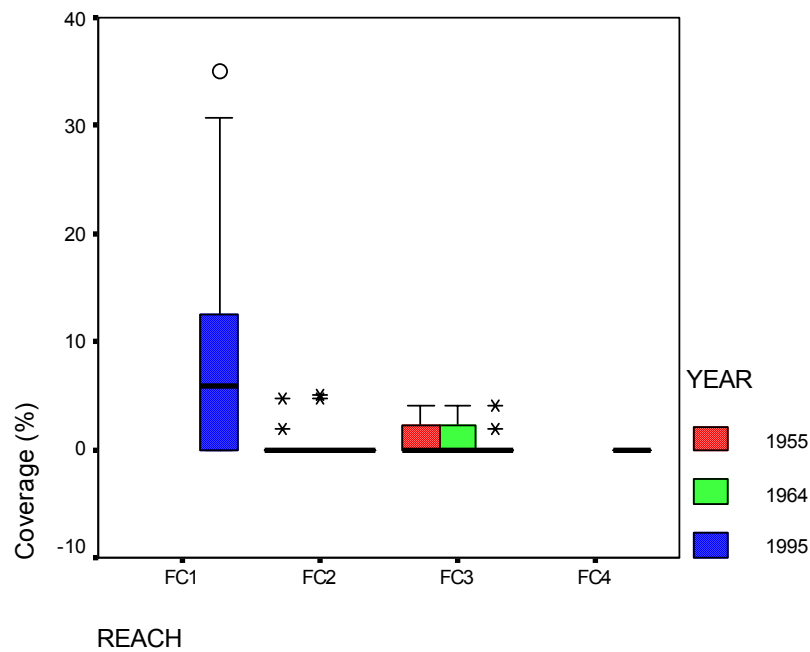
Figure 3-27. Conifer/Deciduous Coverage in Flat Creek in 1955, 1964, and 1995

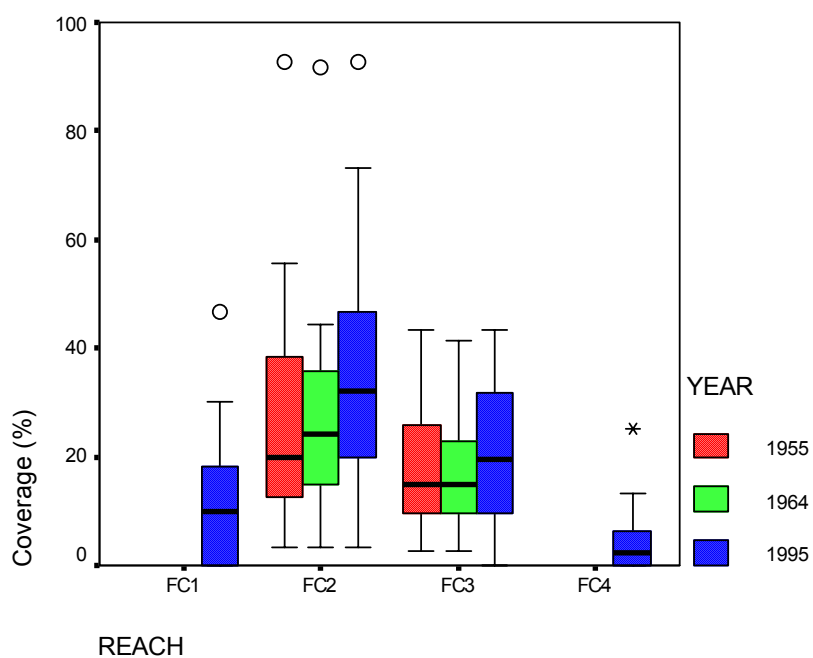
The proportion of woody shrub coverage tended to increase in Flat Creek reach FC2 and FC3 from 1955 to 1995. The increase amounted to 5 to 10% greater woody coverage in 1995 relative to 1955 (**Figure 3-28**). Herbaceous coverage also tended to decrease over the same time period reaches FC2 and FC3 (**Figure 3-29**). No historical coverage was available for reaches FC1 and FC4.

Figure 3-28. Woody Shrub Coverage in Flat Creek in 1955, 1964, and 1995

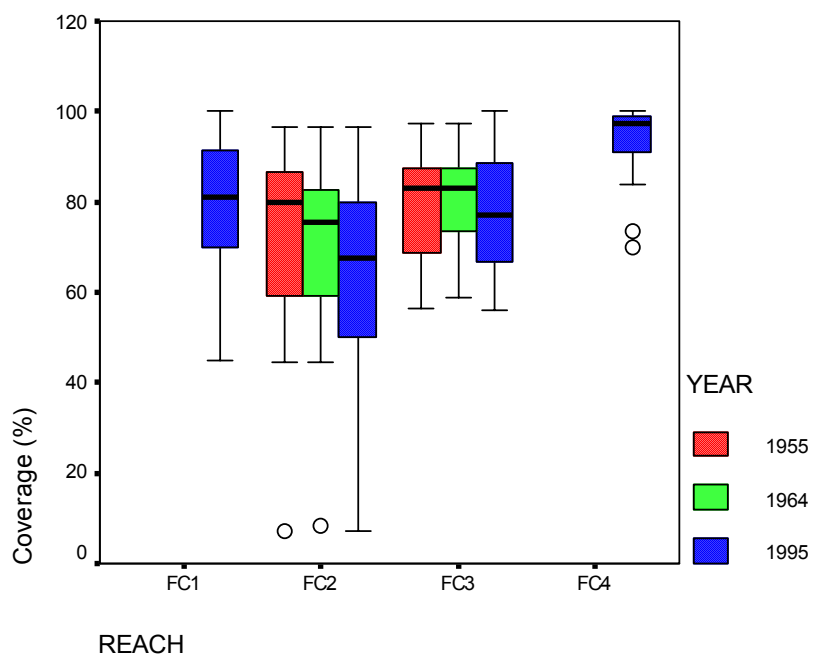
**Figure 3-29. Herbaceous Coverage in Flat Creek in 1955, 1964, and 1995**

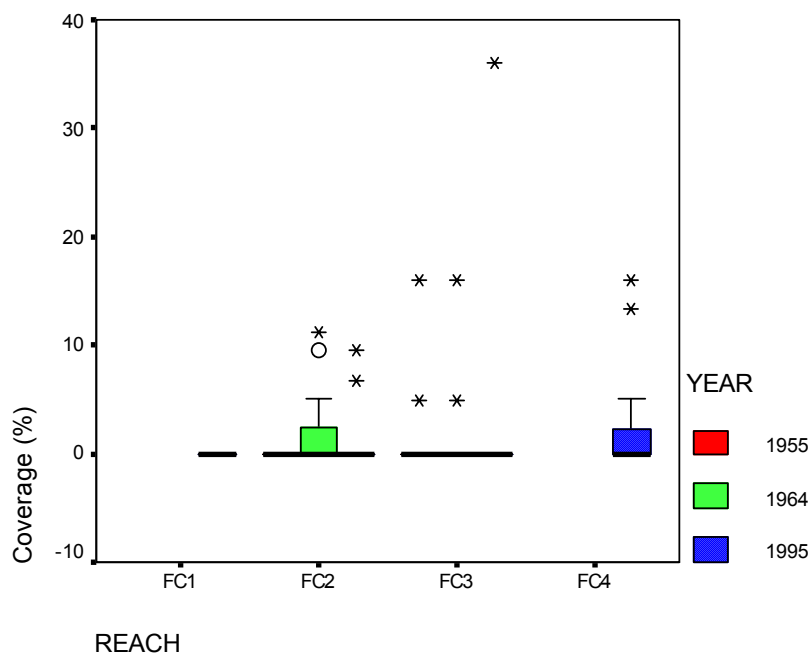
Bare ground was infrequent in Flat Creek and amounted to less than 1% overall. A slight increase in bare ground was observed in 1964 in reach FC2, but was otherwise unchanged from 1955 to 1995.

Figure 3-30. Bare Ground in Flat Creek in 1955, 1964, and 1995
